# Pocklington Beck & Area Drainage

# Pocklington Beck and area drainage

*Research and report by John Nottingham and Roger A Bellingham*

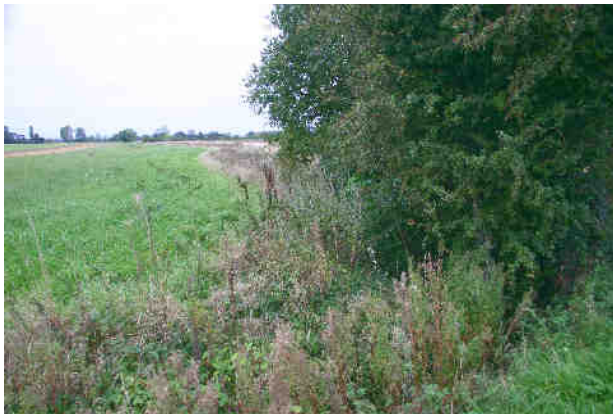
The beck heads initially towards the SSW, is heavily overgrown within a wide strip of uncultivated land and is dry at this point [Fig 1].

Fig 1 “Keldspring Beck” from Miller Lane [1]

The dimensions of this ‘new’ (1759) drain were defined as 3 ft wide at the top, 1 ft wide at the bottom and 2 ft deep; similar to those seen today at Miller Lane [Fig 1].

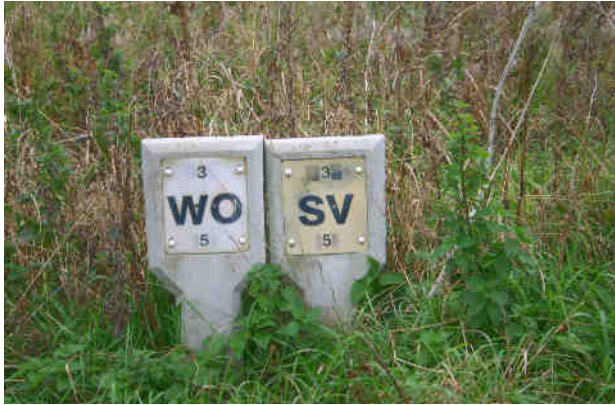
Fig 2 Water hydrants at Keldspring Lane [11]

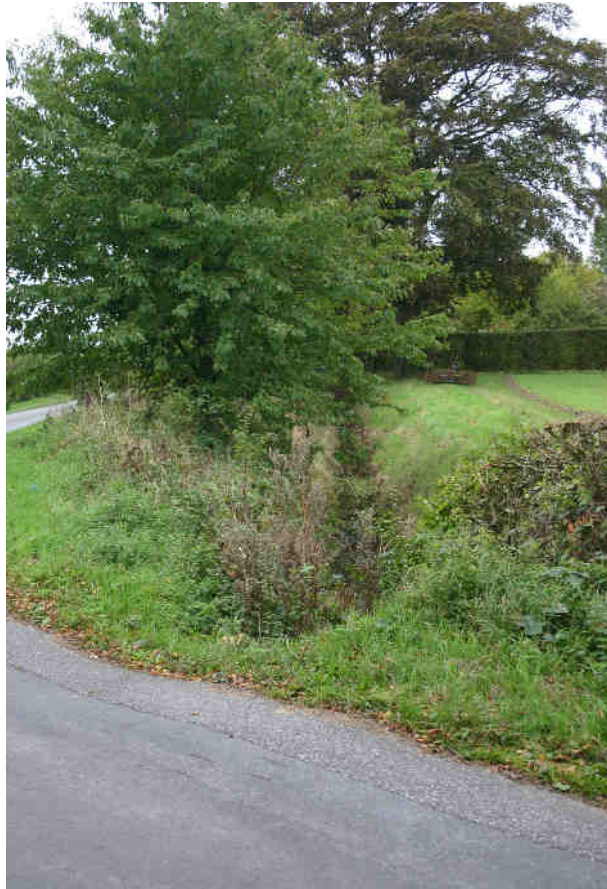
Thereafter, the beck water flows along the NW side of Keldspring Lane [Fig 3], running SW before turning S towards Barmby Moor (near the one-time site of Keld Spring [13], ploughed over in the 20<sup>th</sup> century).

Fig 3 “Keldspring Beck” running alongside Keldspring Lane towards Barmby Moor [12]

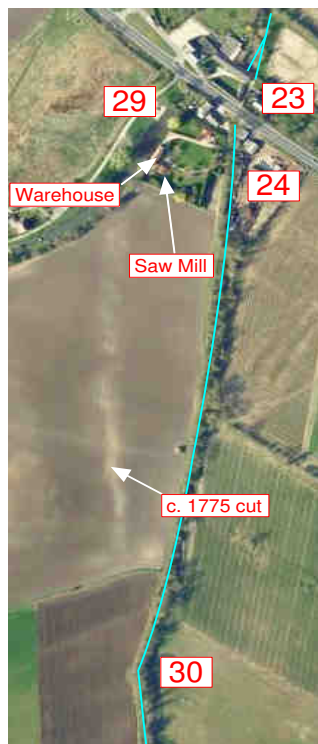
Fig 6 Revised route of Pocklington Beck S of Canal Head (by 1854)

The discontinued interim route of the Beck from [29] to [30], as shown on the Jefferys map [Fig 5], is still evident on the satellite imagery [Fig 6].

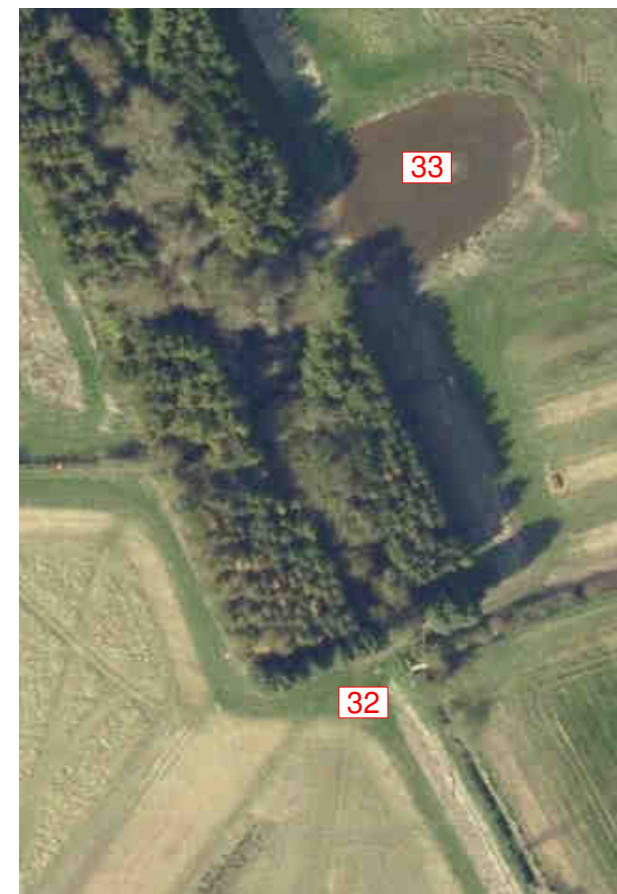
Fig 7 “Clarke’s Spring” and drain near Canal Lane

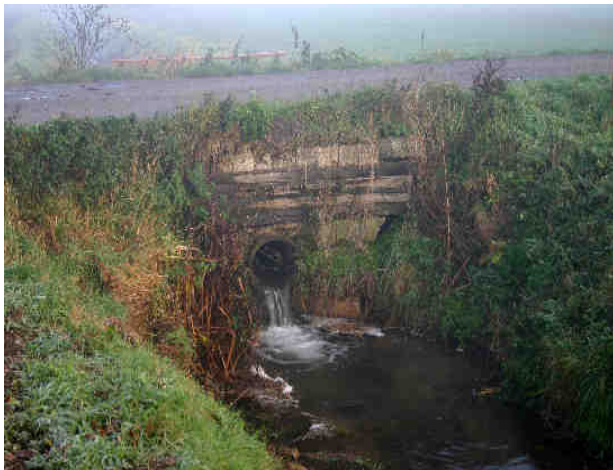
It is noticeable that the revised route of Clarke's Spring drain carries significant water along its length [e.g. Fig 8], in quantity and flow rate very similar to Pocklington Beck itself.

Fig 8 "Clark's Spring" drain near Toft House Farm

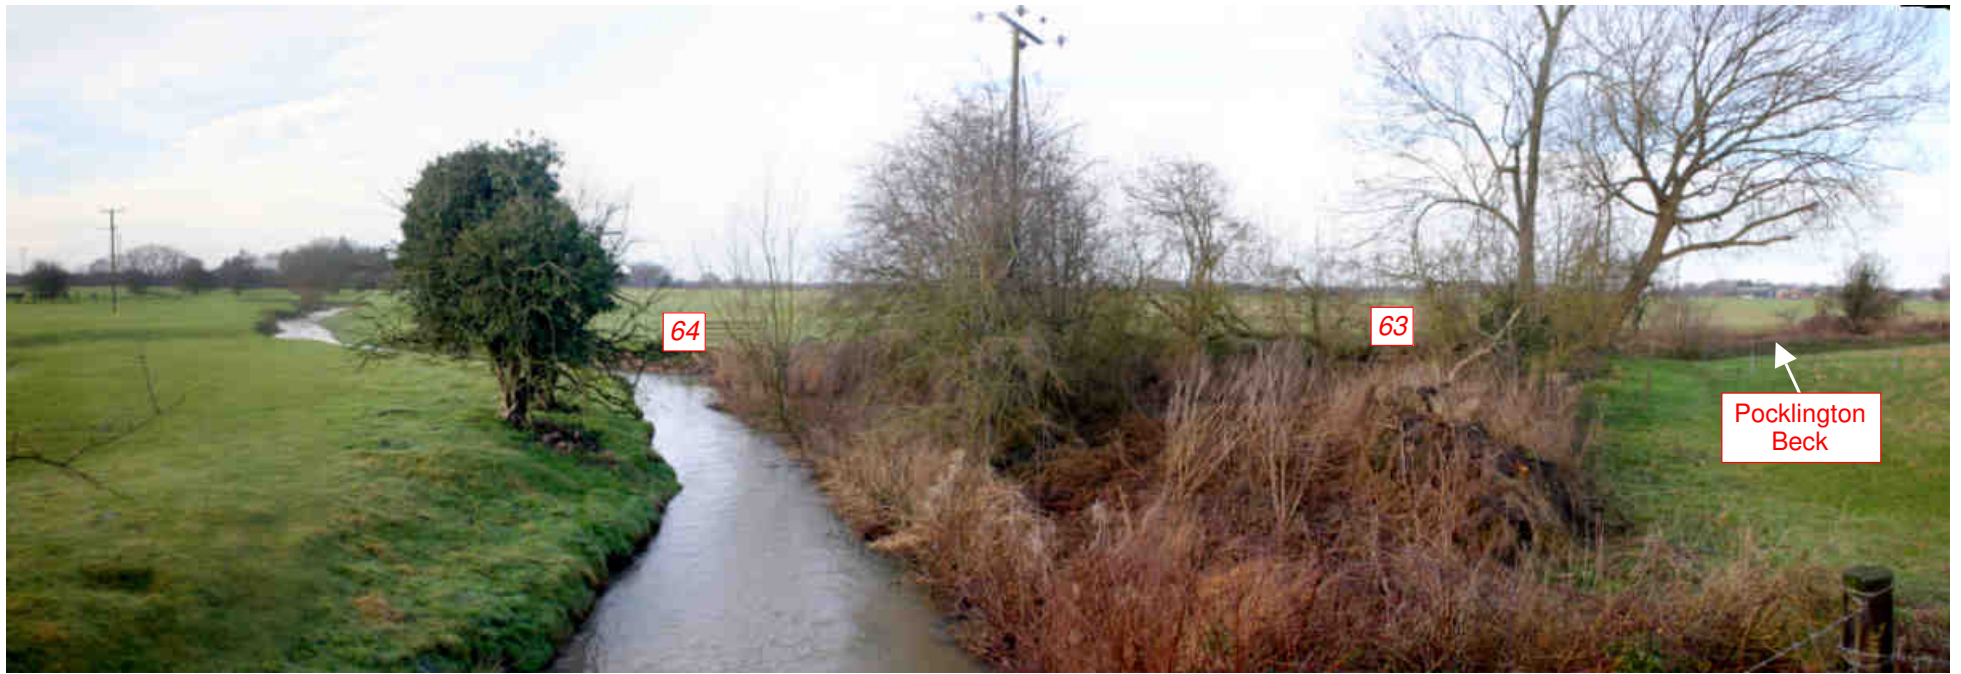
Fig 12 Bielby Beck and the Pocklington/Bielby parish boundary from Crudhall Bridge [26]

Fig 12 taken from Crudhall Bridge [26], to the WSW, shows the Bielby beck flowing SW (left-centre), before bearing left towards the SSW at the point where the merged Pocklington Beck and Clarke's Spring drain join it [64].

The gap between the trees (right-centre) is the line of the Pocklington/Bielby parish boundary approaching the bridge from the WNW [63].

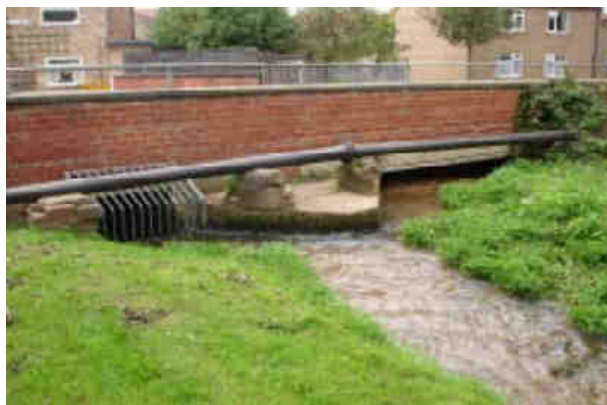
*Fig. 13* (2007) shows the Beck as it approaches London Bridge from the ENE [20] (App. C).

*Fig 13 Pocklington Beck and London Bridge (2007)*

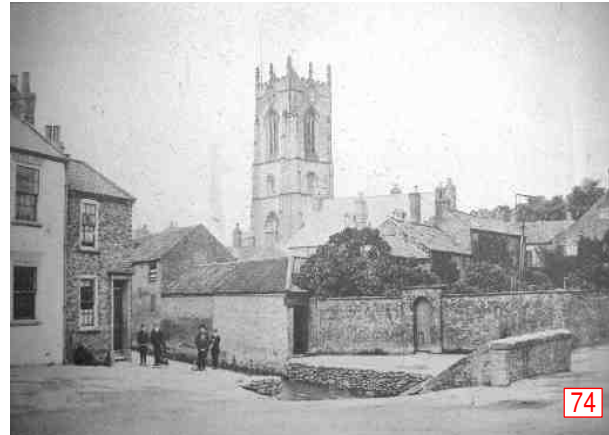
Fig 14 and later maps up to 1854 show the Beck routing S to the end of Grape Lane and flowing under Beast Fair Bridge [74] [Fig 16]. The bridge was located at the present site of the mini-roundabout.

Fig 16 Pocklington Beck flowing along Grape Lane and under Beast Fair Bridge (1897)

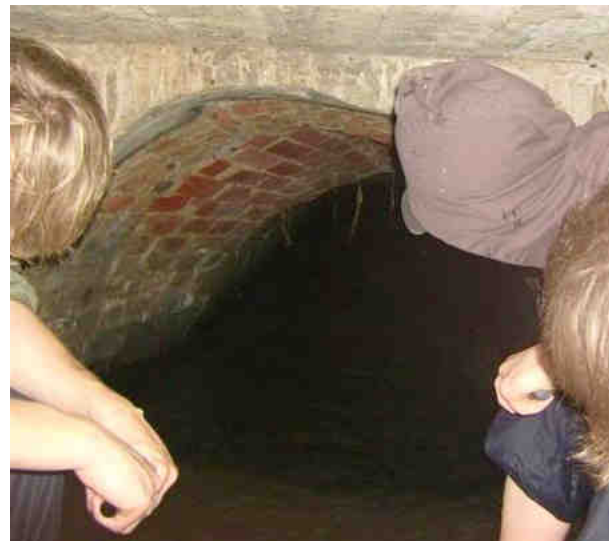
Fig 17 Brick-lined culvert under the mini-roundabout, thought to be looking N along Grape Lane

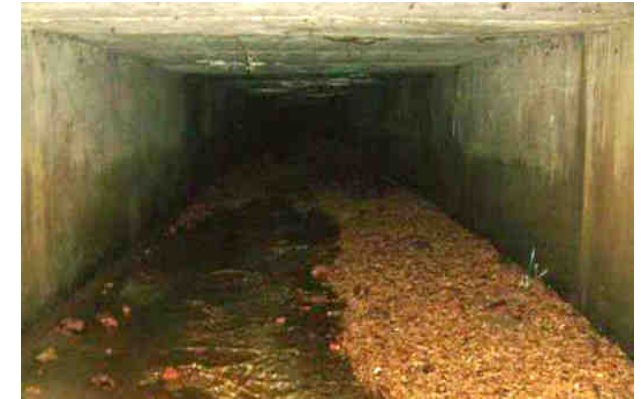
Fig 18 shows a modern, reinforced concrete culvert approaching the mini-roundabout. This is presumed to

be the one described in the 2007 Flood Report [Ref. 5], routing SW under Market Place via Railway Street to the roundabout. Whether this culvert is inter-linked with the Beck near St. Peter's Square is unknown.

Fig 18 Concrete culvert under the mini-roundabout, thought to be looking NE along Railway St.

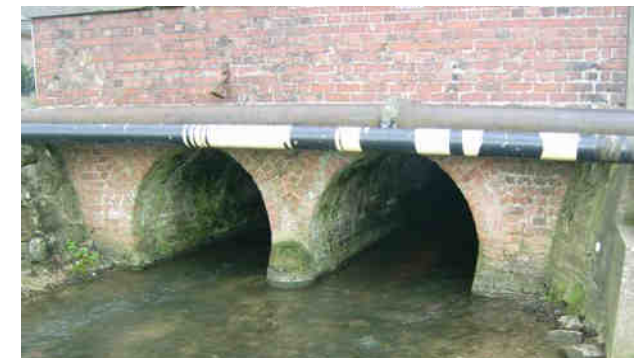
Watson's map of 1855 shows the section SW of Beast Fair Bridge [74] to have been partly covered but, after 1897, the whole section of this revised course of the Beck was culverted from Pavement [72] to the bridge, then double-culverted to a point opposite Pocklington School main buildings [75] [Fig 19].

Fig 19 Double exit culverts along West Green Road

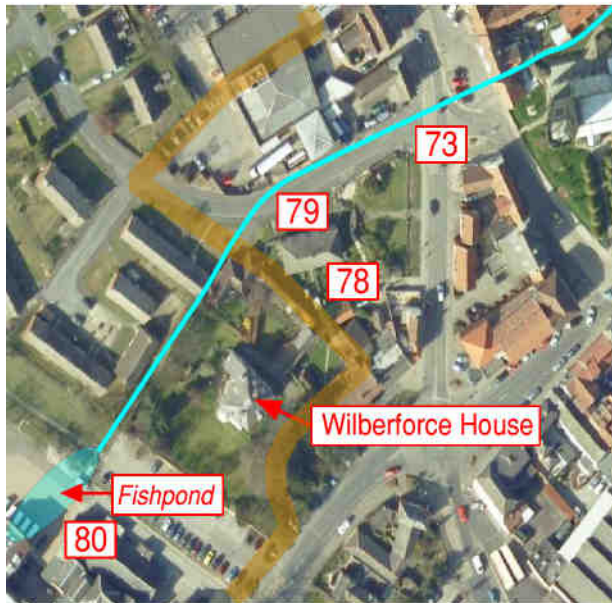
Fig 23 Pavement to Pocklington School

Working on that premise, the interim course of the Beck seemingly routed behind the area of the present Wilberforce House [Fig 23 overleaf]. Much of the original rear garden of the property is believed to have been cut back in the 1960s and the projected course of the Beck appears to run along the revised rear boundary of the property. The tentative route of the Beck then runs across the old railway track bed (immediately NW of the end of the present car park) and thence to the presumed location of the fishpond [80].

It is reiterated that nothing has been identified on the ground to support any of this projected, interim route of the old Beck, from the N end of Grape Lane [73] as far as Pocklington School [81], so confidence in it must remain low.

- ❑ Turning SW [79] and shortly cutting through the 2-3 feet high tongue of land to the NW of Mount Pleasant [78] [Fig 23];
- ❑ Continuing alongside the present rear boundary of Wilberforce House, across the line of the railway track bed and flowing into the NE end of the presumed location of the fishpond [80];

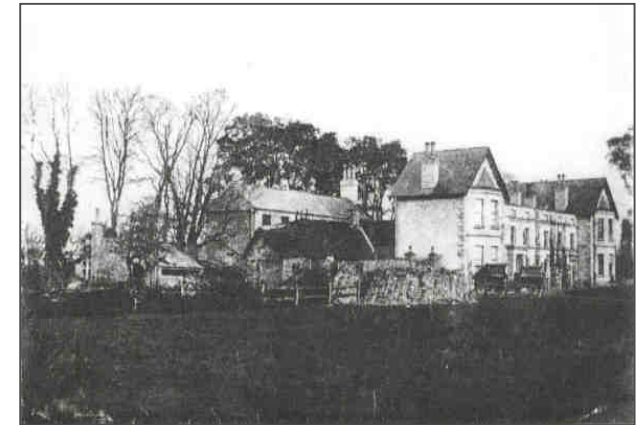
Clearly this is not a natural feature of the Beck but it is speculated that the line of the water course may have been realigned, some time after the original school buildings were established c. 1514, for example to provide space for buildings erected at some later date behind the original school premises [Fig 25].

Fig 25 Pocklington School built c. 1514 and backed by later buildings (Photo: 1853)

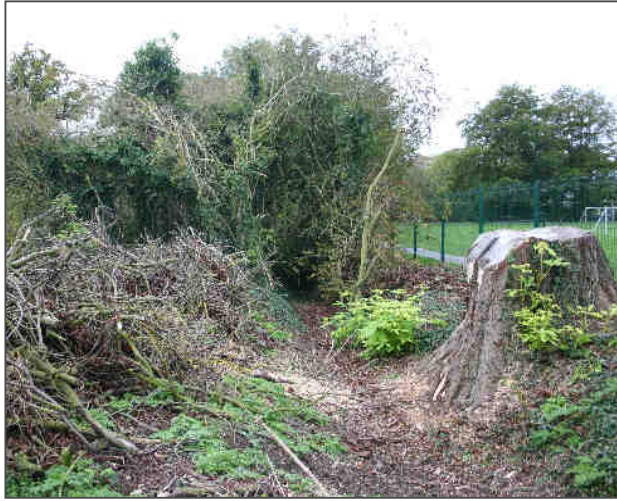
Presently its depth varies considerably, from 4-5 feet to as little as 1 foot [e.g. Fig 26 overleaf]. However, this is thought most likely to be due to varying depths of natural detritus filling up the ditch, perhaps over a period of centuries.

Fig 26 Remains of ditch SW of Pocklington School

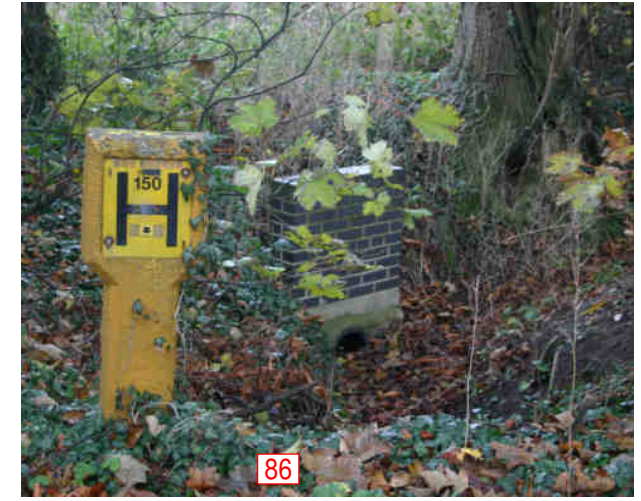
As the ditch nears the West Green road [86], it turns sharply left towards the ESE. At the corner, there is a relatively modern, double-culvert portal, made up with concrete blocks and mortar and topped by a wall of engineers brick [Fig 28, looking NW]. There is also a water hydrant sited between the portal and the road.

Fig 28 Hydrant at the ditch near White Mill [86]

The double portal [86] faces WNW and is discussed in more detail later. The condition of the various portals [83, 85 and 86] suggests the culverts may have been installed at the same time, c. 1854-1892.

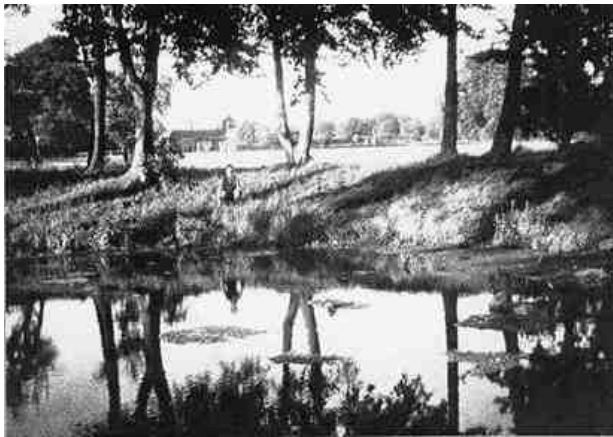
The pond (marked as a ‘Swimming Bath’ on App. D) is believed to have been used by Pocklington School from the 1800s and was replaced before WWII [Fig 29]. Its condition today is much deteriorated but the water level seems to be the same, suggesting it is either an isolated feature or there is a water source with related outlet.

Fig 29 Pocklington School old Swimming Bath [96]

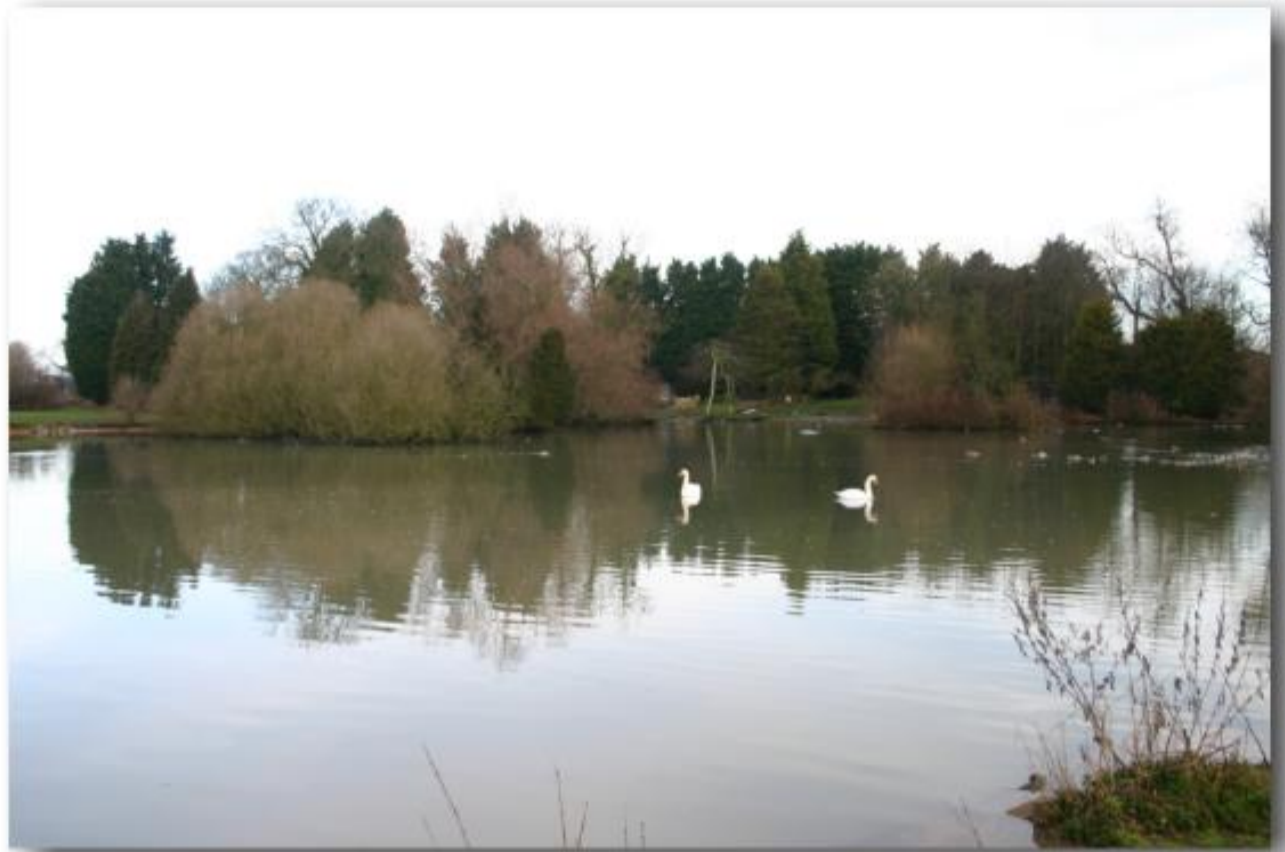
Fig 31 Permanently flooded area south of White Corn Mill (c.f. Fig 20 on p15)
